NASA  
Reference  
Publication  
1161

# Evaluation of Multilayer Printed Wiring Boards by Metallographic Techniques

*An Illustrated Guide to the  
Preparation and Inspection  
of Plated-Through Hole  
Test Coupons Based on the  
Requirements of MIL-P-55110D*

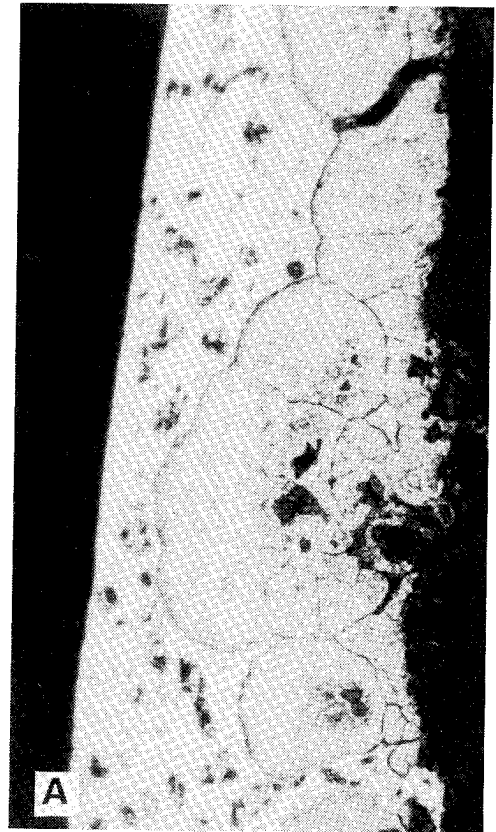
Figure 9. Examples of plating nodules in barrel plating.

- A. NODULES ASSOCIATED WITH BRITTLE PLATING PROBABLY RESULT FROM PLATING BATH COMPOSITION PROBLEMS. THE NODULES WOULD BE ACCEPTABLE; THE CRACKS ARE NOT. ETCHED, 500X.
- B. NODULES IN ONE PLATING LAYER ON ONE SIDE OF THE BOARD MAY RESULT FROM IMPROPER POSITIONING OF ELECTRODES DURING PLATING. ETCHED, 50 X.
- C. HIGHER MAGNIFICATION VIEW OF HOLE ILLUSTRATED IN B. ETCHED, 175 X.

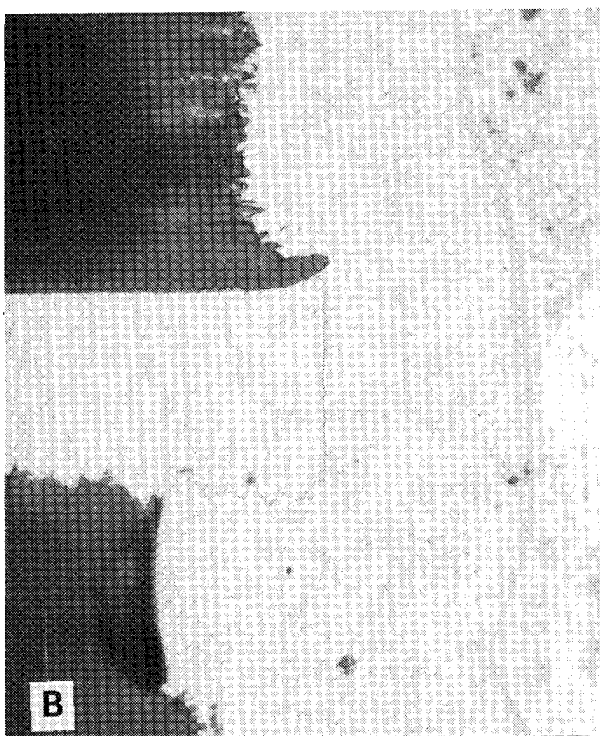
**A. ETCHBACK EFFECTIVE ON BOTH SIDES OF INTERNAL CONDUCTOR. ETCHED, 400X.**

**B. ETCHBACK EFFECTIVE ON ONE SIDE. ETCHED, 400X.**

**C. SHADOWING ON BOTH SIDES. ETCHED, 200X.**

Figure 20. Etchback should be effective on at least one side of each internal conductor.

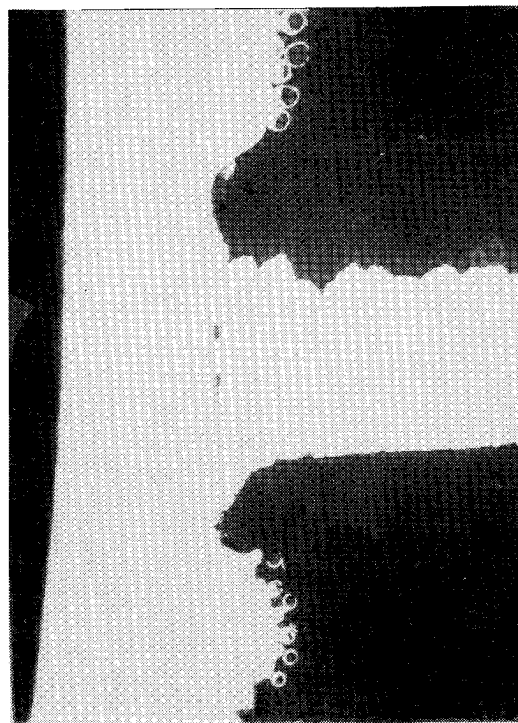
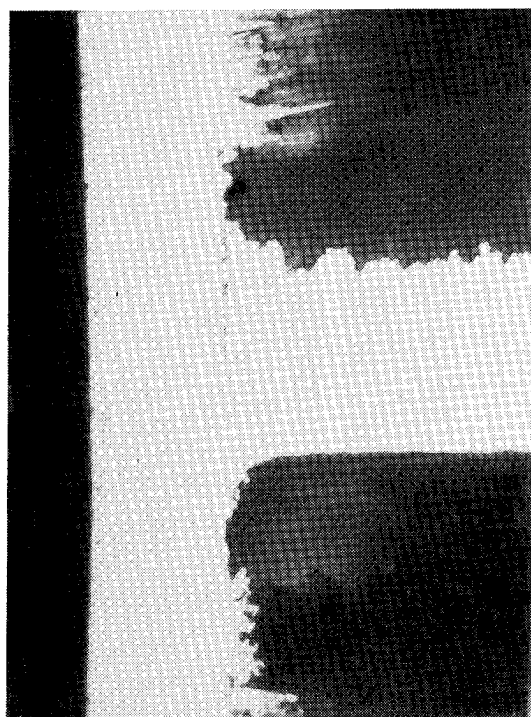
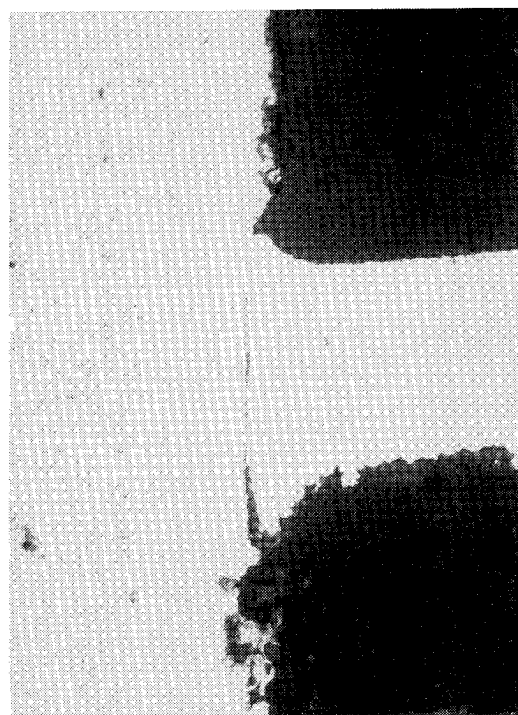
**GOOD: NO VISIBLE DEFECTS**

**MARGINAL (?) ~ 10% DEFECTIVE**

**MODERATELY SEVERE: 10 – 50% DEFECTIVE**

**SEVERE: > 50% DEFECTIVE**

Figure 36. Examples of defect levels at barrel/innerplane junctions. All unetched, at 400X.

The "fine line" defect is characterized by the presence of a narrow faint line which extends across the full thickness of the foil. Defects associated with resin smear are not necessarily continuous, and often manifest themselves as dark spots or discontinuous lines at the barrel plating/innerplane junctions. Figure 36 illustrates four such defects affecting from virtually none to almost all of the junction, with the first one clearly acceptable, the last two clearly rejectable, and the second one perhaps open for debate. Just about every intermediate condition has been seen. It becomes a matter of judgement which coupons to accept and which to reject. For example, the junction shown in Figure 37 has a few isolated spots of contamination which are plainly seen in the unetched condition, but most of the junction is sound. In contrast, the junction illustrated in Figure 38 has a linear defect (in this case caused by epoxy smear) extending more than halfway across the junction. A small, rounded defect is considered less likely to propagate into an actual separation than is a linear flaw—much as minor porosity in a weld is not as severe a defect as is a crack. For non-linear defects, it comes down to a matter of whether the remaining cross-sectional area of the joint is sufficient to withstand the applied stress expected in service. The hole containing the junction shown in Figure 37 may be considered acceptable if that is the worst defect that it contains, while the hole shown in Figure 38 should be rejected.
